approach

APRIL 1960

APPROACH

The Naval Aviation Safety Review

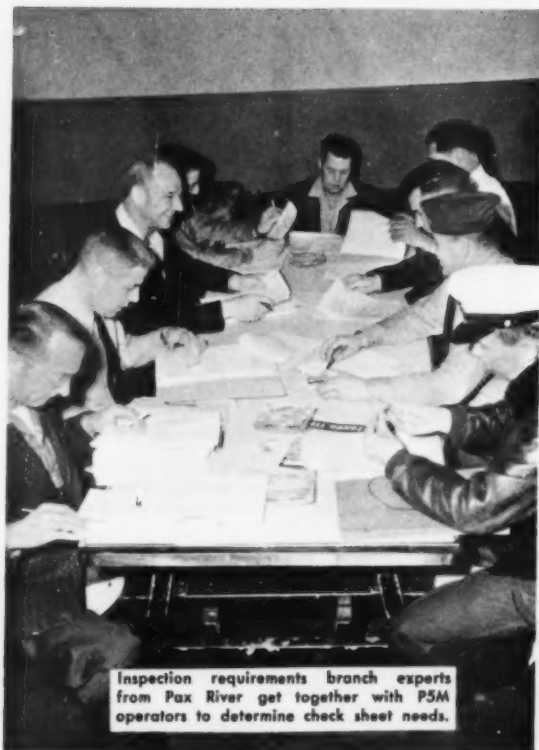
Inspection requirements branch experts from Pax River get together with P5M operators to determine check sheet needs.

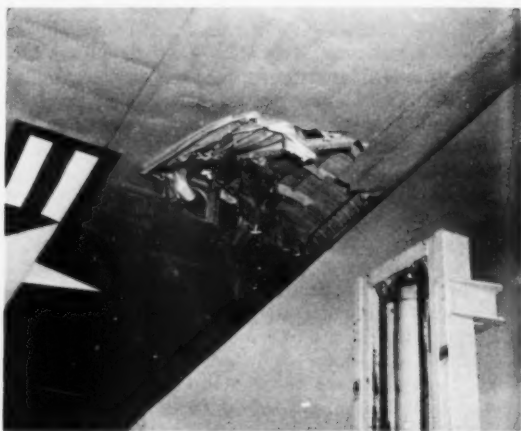
UNQUALIFIED—The driver tried to pass under the wing of this R4Q-2 with a fork lift. The upright rails of the fork lift struck the under side of the aircraft wing rupturing the skin and main spar about 12 feet from the wing tip. The driver was not familiar with nor qualified to operate this type forklift. Therefore, a cause factor of supervisory error was assigned.

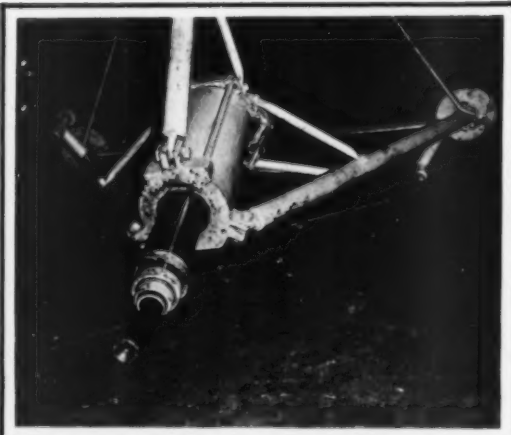
An A4D was being jacked for landing gear check. Upper extension of jack under port wing failed, allowing port side of aircraft to fall. Top of jack punctured wing. Upper extension of jack was over extended. When jack received weight of aircraft, remaining engaged threads stripped, allowing aircraft to fall. This is one of two nearly identical types of jack, one of which has a 20-inch upper extension, the other (this type) an 8-inch extension. Personnel involved assumed all to be the same, and as there is no stop or warning mark to indicate the situation, the jack was extended to a point where only one or two threads retained the failed part, rendering it incapable of supporting the aircraft.

It is recommended that the last 2" of the mechanical extension of all jacks be painted red.
